Assessment Report for
State – Delaware, SPS Experiment – 0100

Visit date: October 28, 2003

A visit was made to the Delaware SPS 0100 site on October 28, 2003 for the purposes of conducting an assessment of the WIM system located on US 113 South near Ellendale at Mile Post 25.04. This site is not considered a strong candidate for validation.

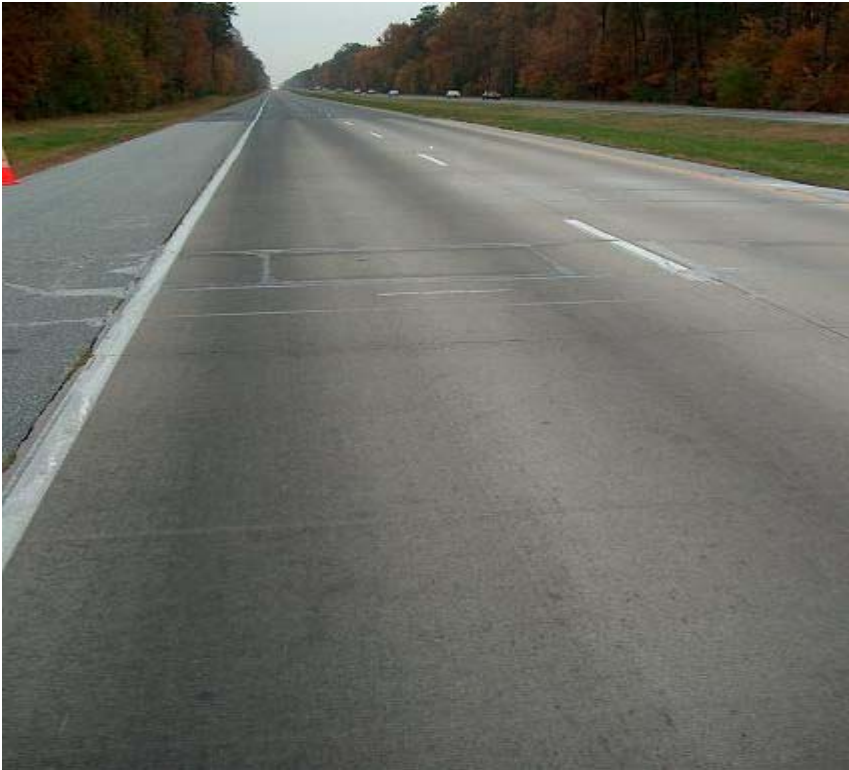
Figure 13-1 Pavement condition of Delaware 0100 at the sensors

The pavement condition is such that it may have a minor contribution to an inability to calibrate the system to obtain research quality data. The WIM sensors are in PCC pavement. There is a slight drop from the asphalt to the PCC pavement surface about 50 feet prior to the first sensor. The asphalt and PCC pavement was in good condition around the WIM sensors

The pavement condition is good for the Delaware 0100 site with little or no distresses. However, there is a slight drop where Asphalt Concrete pavement changes to Cement Concrete pavement 47 feet 9 inches before the WIM sensors. This slight drop did not significantly alter the dynamics of the trucks over the WIM site. Figure 13-1 shows the condition of the pavement. Figure 13-2 shows transition from asphalt concrete pavement to cement concrete pavement.

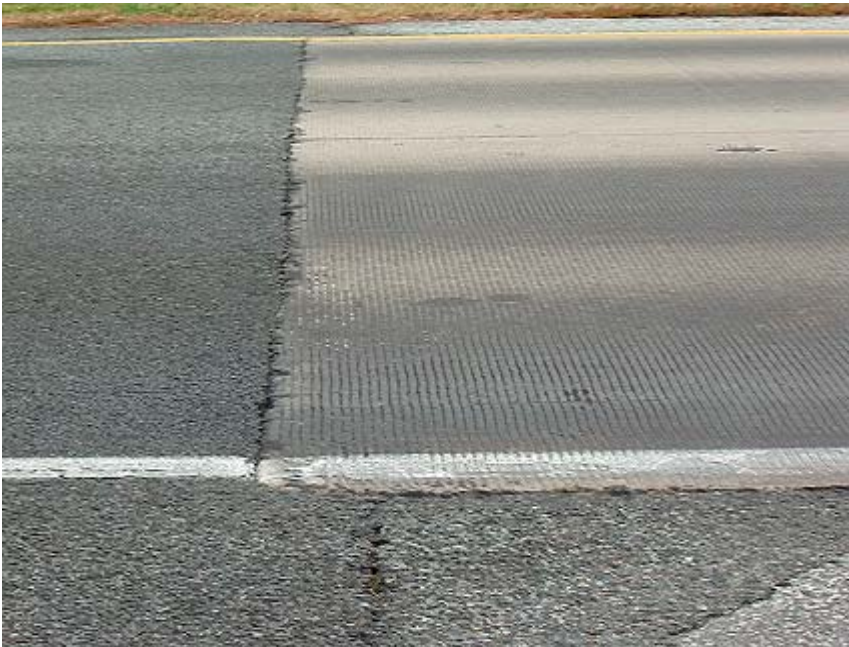
Figure 13-2 Transition of asphalt concrete pavement to cement concrete pavement

The WIM sensors are in PCC pavement, which begins 47 feet 9 inches before the leading WIM sensor. There is a slight drop from the asphalt to the PCC pavement surface, which seemed to affect the body of the truck (a small dip after it passed over the interface), but was not discernable to the eye if it was affecting the tire loads at the WIM sensors. The asphalt and PCC pavement was in good condition around the WIM sensors

The pavement interface may need to be smoothed by grinding such that it will not cause the trucks to start oscillating after they pass over the interface of the asphalt and PCC pavement. This is not considered necessary to be done prior to a validation.
